# Investigation and Analysis of an Explosion at the GOEX Black Powder Manufacturing Facility

Ali Reza<sup>\*a</sup>, Zuhair Ibrahim<sup>a</sup>, Tim Vaitekunas<sup>b</sup>

<sup>a</sup>Exponent, Inc., 5401 McConnell Ave, Los Angeles, CA, USA

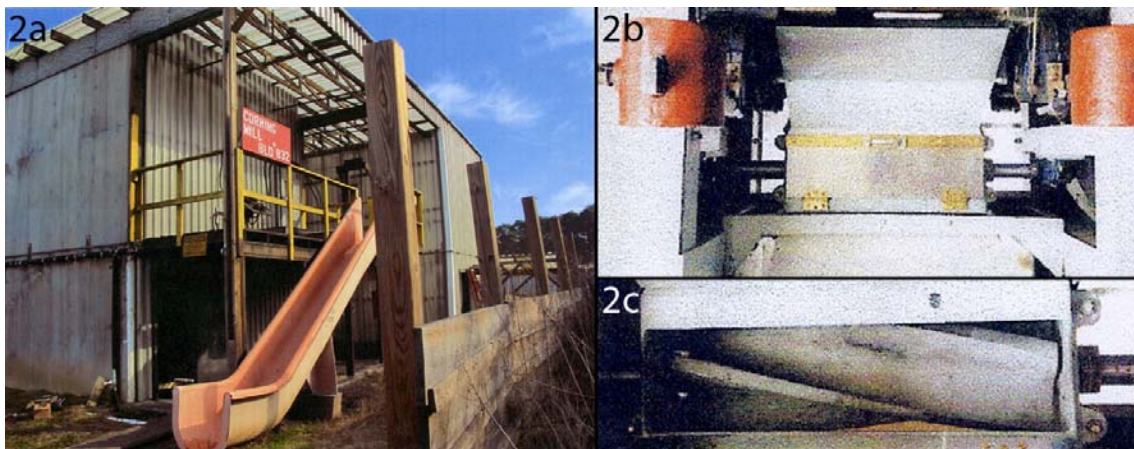
Figure 2: Corning mill (a), hopper (b) and aluminium worm (c)

An alternate mechanism for the explosion that could not be ruled out was a pre-existing defect or void in the cast aluminium worm that caused premature fracture within one of the worm blades as it turned. It is possible that a fragment of aluminium broke off and rubbed against the black powder, creating sufficient frictional heat to ignite the material. The subsequent ignition then propagated back into the hopper. Goex confirmed that they had last replaced the worm and hopper in 2006, and their procedures did not include any non-destructive testing or evaluation of rotating components to verify that there were no pre-existing defects or fractures in their equipment. However, Exponent was not able to recover any fragments that

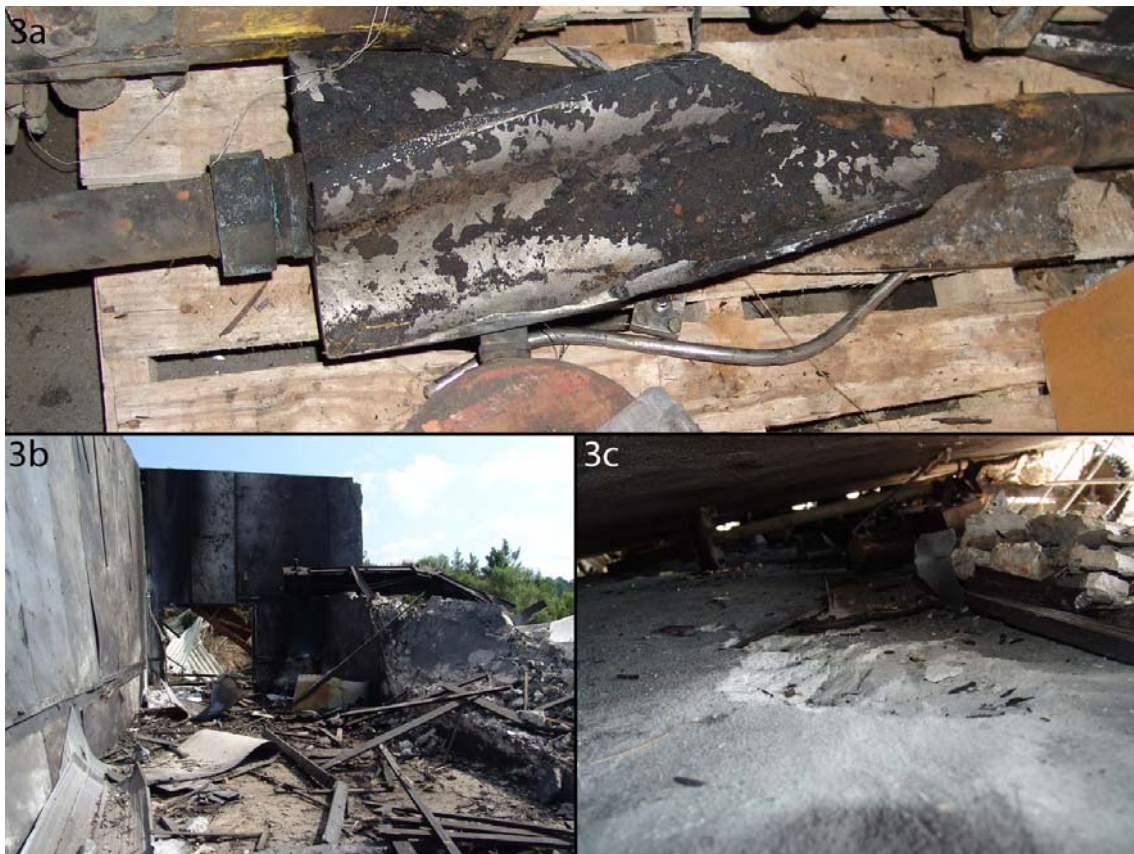
Figure 3: Fragmented worm (a), destroyed corning mill (b) and crater under hopper and worm (c)

Damage indicators documented by Exponent included the condition of the concrete floor slab and walls and recovered fragments of the cast aluminium hopper and the screw worm. Investigation confirmed that the origin of the primary explosion was inside the hopper directly above the worm at the head of the corning mill screens and rollers. The primary explosion fragmented the hopper and the aluminium worm

Careful examination of the floor confirmed that the only evidence of localized cratering in the concrete occurred directly under the hopper, which confirmed that the primary explosion occurred within this equipment (Figure 3c). The lower portions of the surrounding concrete walls were also fragmented and had collapsed outward onto the floor slab immediately around the hopper. Multiple fragments of the aluminium hopper and worm recovered after the explosion ranged in size from 1 inch to 9 inches, indicating a relatively high degree of brisance, particularly within the hopper (Figure 4a). Many fragments also exhibited surface cracks characteristic of high strain rates (Cook, 1958) that would be expected at the seat of the explosion (Figure 4b). Basco et al. (2010) indicate that the heat of explosion of black powder is approximately 60 % of TNT. Since the mill had operated for approximately 10 min prior to the explosion, the quantity of black powder within the hopper at the time of the explosion was approximately 158 kg (400 lb.), or a TNT equivalent quantity of 95 kg. Assuming a 1 m standoff distance between the hopper and the concrete slab, a detonation within this quantity of explosives is sufficient to cause the localized cratering observed.

The plant had recently re-qualified a very detailed Process Safety Management plan, which included a hazards review as required by industry standards. Goex also maintained a strict series of Standard Operating Procedures designed to regulate step-by-step activities during the manufacturing process. However, the results of this investigation have highlighted certain structural shortcomings in their procedures that have since been corrected. Due to the obvious risk of foreign contaminants, floor sweepings should not be incorporated back into the manufacturing process. In addition, any equipment that rotates or otherwise imparts mechanical energy to explosives should be x-rayed or otherwise tested in a non-destructive manner to confirm that there are no occlusions, voids or other latent defects before it is placed into service. A regular non-destructive examination and requalification of the equipment should also be incorporated as part of the preventive maintenance program. The Process Safety Management plan and Hazards Review should include a What-if analysis to explore the effects of equipment failure in operations where energy is imparted to explosive materials.

The authors also reiterate certain NFPA 495 requirements that, in their experience, have not been consistently followed by industry and have caused explosions at other facilities. All explosives manufacturing and process areas should be regularly swept and kept clean, dry and free of grit, paper, empty packages and other assorted rubbish. Non-sparking tools should be used during all aspects of the manufacturing process, including housekeeping, and any floor sweepings should be disposed of in a manner approved for the explosive product itself. All collection systems should be cleaned at a frequency that eliminates hazardous concentration of explosives dusts or powder from accumulating in pipes, tubing and ducts or within hidden compartments. Finally, any explosive materials or residue should be removed from process equipment and the immediate surroundings before hot work or repairs that might produce heat sparks or flame is performed in the area.

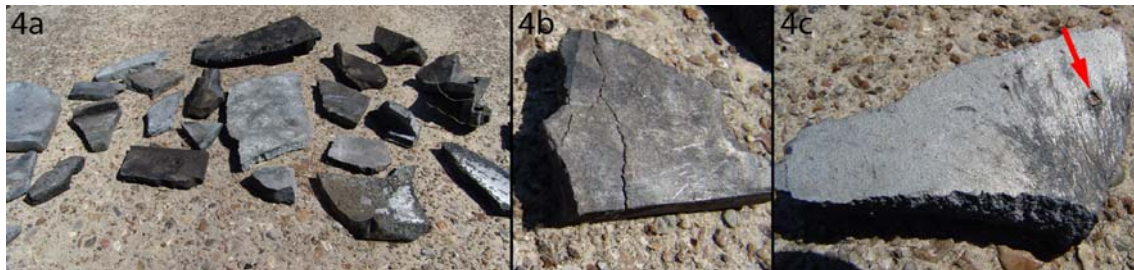
Figure 4. Recovered hopper fragments (a), cracks on hopper fragment (b) and embedded quartz (c)

A piece of quartz that had contaminated the chipped black powder from the press bay batch impacted the sides of the hopper. The friction generated sufficient heat to initiate the explosion. One of the recovered fragments from the hopper exhibited a distinct starburst pattern that is very characteristic of a surface initiation of explosives. A quartz pebble was also discovered embedded within this fragment, directly below the starburst pattern. Surface melting was observed on the aluminium surrounding and below the pebble (Figure 4c). Goex confirmed that, due to the design of the mill, a significant amount of material from each batch would spill on the ground during the corning operation. Operators would sweep the floor and incorporate this material into the subsequent batch as it was introduced into the hopper. Accordingly, accidental introduction of rocks or quartz into the mill (for example, materials being tracked into the mill by an employee) was quite possible.
